Vehicle Description

Mercedes-Benz CLA 45 AMG

DATE INSPECTED: 01/03/2016 INSPECTION POINTS CHECKED: 150+

Odometer Reading 12633 Registration Number MBCLA45 11/06/2017 **Registration Expiry** Pre-purchase Reason for inspection

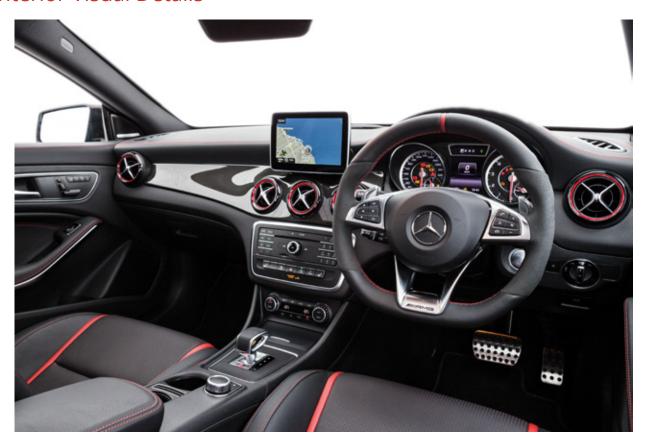
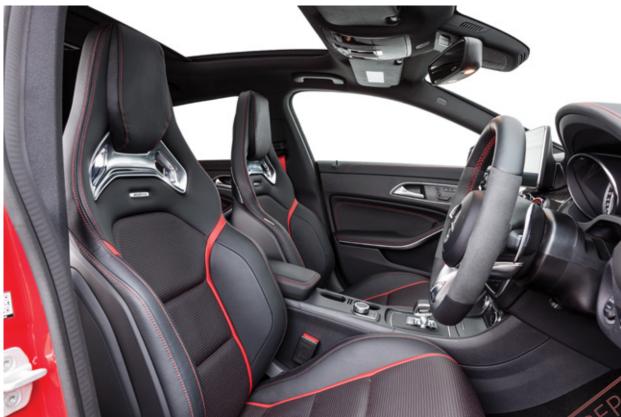
Interior Visual Details

Interior **	*
****	Seats Very good condition
****	Seat Belts All working and in good order
****	Other Trims All in good condition , slight scuff marks in lower section of all door trims , respectable condition for age and wear
****	Radio
****	Rear Window Demister Operational, no scratches in demister lines
****	Air Conditioning Working and cold
****	Heater Demister All working , all levels checked
****	Washers & Wipers All working
****	Horn Working order
****	Doors, Locks & Hinges General wear and tear marks
****	Window Operation Working from all window switches , window tinting has been installed to all windows , no scratches detected
****	Dash Warning Lights & Gauges No warning lights on , all systems are serviceable
****	All Lights All lights are operational and lenses are complete
****	Other Overall very good condition for the age and kms

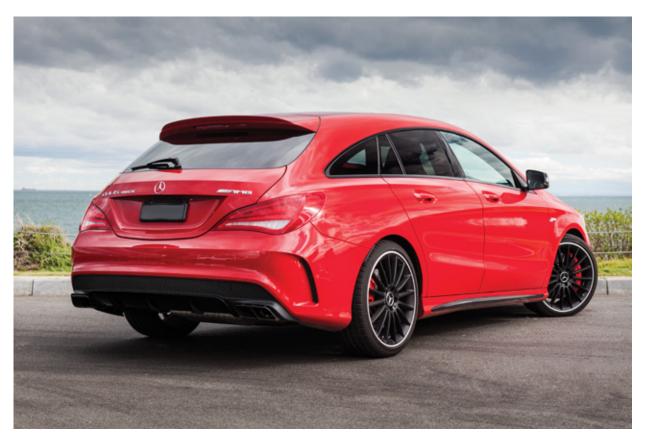
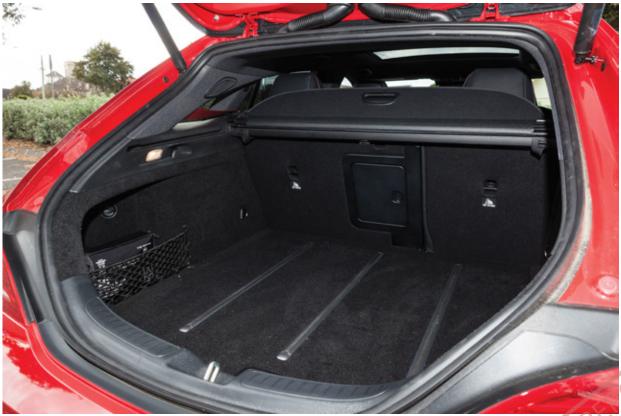
Exterior Visual Details

Exterior **	$\stackrel{\wedge}{\sim}$
****	Rust No rust detected , vehicle has not seen a lot of unsealed roads by the look of the underbody
***	Body Repairs Rear tailgate has been re-painted

****	Glass & Mirrors All glass is tinted and in good condition
****	Sunroof, Aerial & Convertible Aerial & Sunroof fitted. All in working order.
****	Frames & Members No structural damage detected at the time of inspection

****	Under Body Parts Some inner guard linings have been replaced possibly on the drivers side
****	Front Suspension Good condition consistent with the age and kms

****	Rear Suspension Good condition consistent with the age and kms
****	Steering Components Good condition consistent with the age and kms
****	Transmission Housing Manual transmission , slight leakage detected

****	Exhaust Original condition
****	Differential Original condition , no noises detected
****	Drive Shafts Slight leakage from outer c.v. boot. Front tail shaft bracket and rear shaft has been replaced

***	Other Overall good condition consistent with the age and kms, some paintwork in o/s of the vehicle needs attention also rear tailgate needs to be repainted

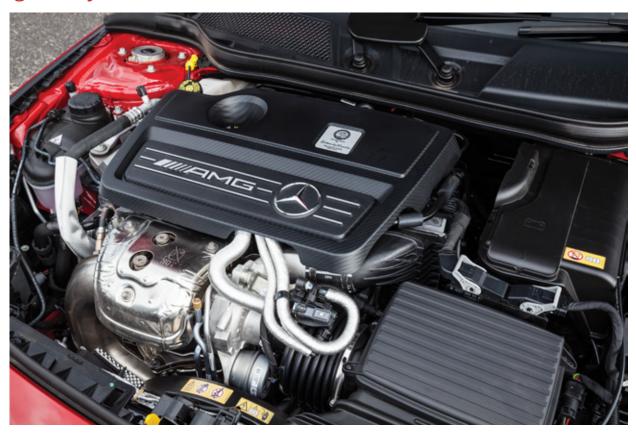
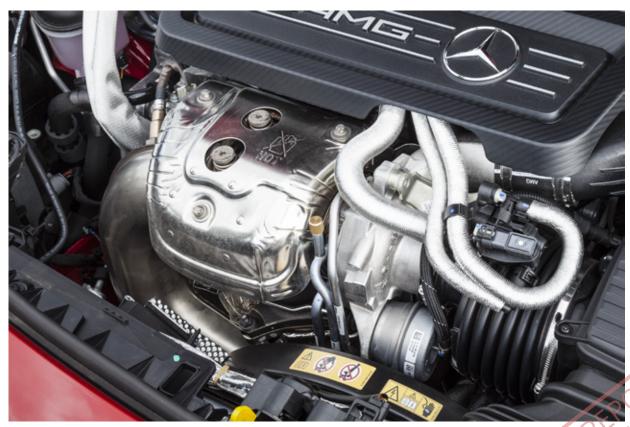
Engine Bay Visual Details

All fluid levels are at correct level , wrong coolant has been installed , vehicle should have red coolant fitted not green

Evidence of previous coolant leak in top of radiator tank, top use area.

Engine repairs have just been performed to the front of the motor in the timing case area, extent of repairs

unknown. Current coolant needs to be flushed and replaced with correct coolant.

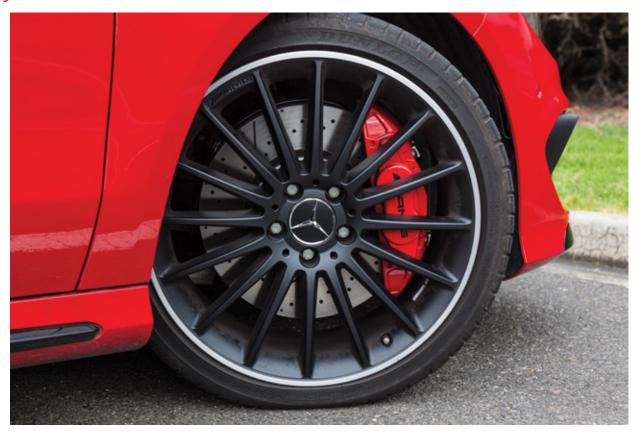
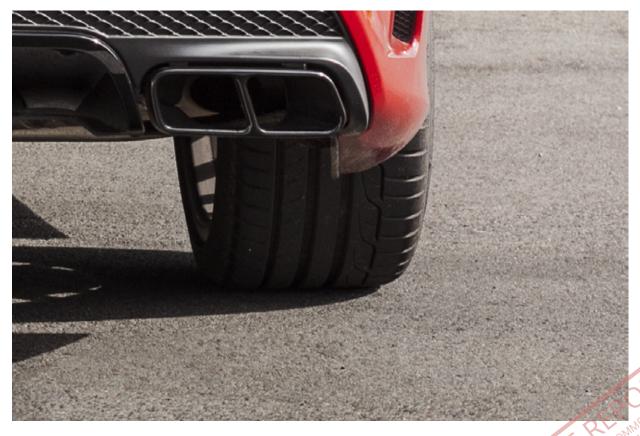
Tyres, Wheels & Brakes Visual Details

Front brake pads need replacement before next service approx 70% worns

Discs will require machining

Adjustment needed

Front wheel bearings are noisy

Brakes require service soon
